## Memorandum

*To: Lynnfield Center Water District*

*From: Angela Moulton, P.E., CDM Smith  
Adrien Fleury, CDM Smith*

*Subject: Task Order 7: Apple Hill Water Quality Investigation – Summary of Results*

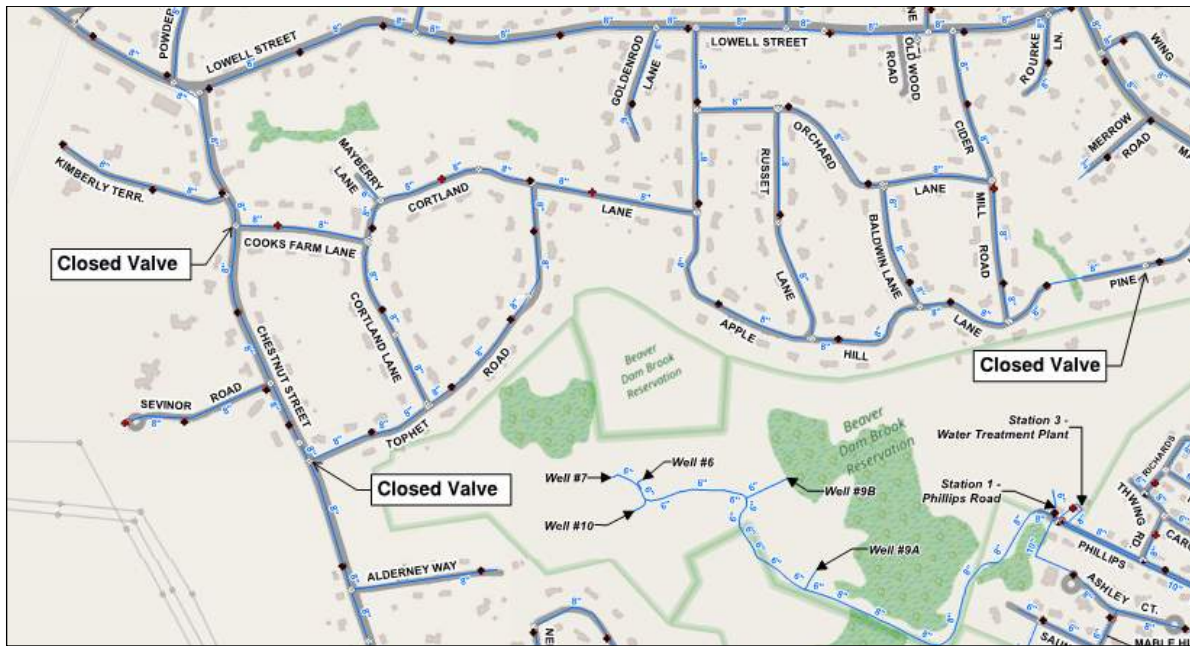
**Figure 2 – Location of Valves Closed by District Staff in 2018**

In spring 2018, District staff closed three gate valves in the Apple Hill neighborhood in an effort to reduce flow reversals in the area. The three valves are located on:

- Tophet Road at Chestnut Street,
- Cooks Farm Lane at Chestnut Street and
- Pine Hill Road.

The locations of the closed valves are shown in **Figure 2**.

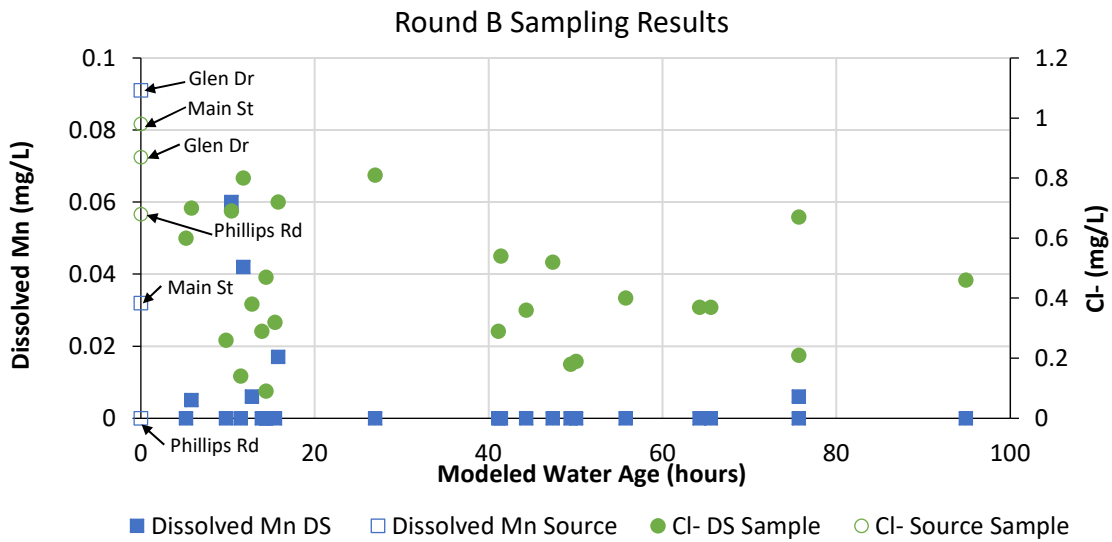
**Figure 6 - Dissolved Manganese and Free chlorine Residual vs. Modeled Water Age (Sample B)**

**Figure 6** shows that both dissolved manganese and chlorine residual were found to have a generally inverse relationship with water age during Sample B.

Dissolution of iron and manganese in water depends on contact with an oxidant (such as chlorine residual or dissolved oxygen) and is inversely related to water age. Over time, the dissolved form of the iron and manganese is oxidized to the particulate form and can settle out of solution. Water age analysis was performed using Infowater. Full results of the water age analysis are included in this memorandum. To analyze the relationship of dissolved manganese to the oxidants over time, the following plots were created:

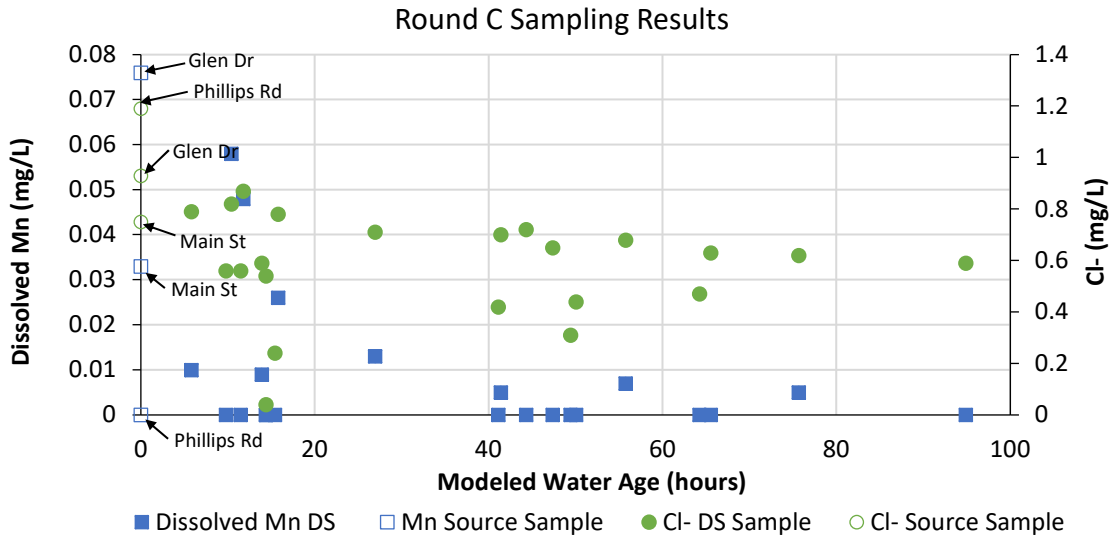
**Figure 7 - Dissolved Manganese and Free Chlorine Residual vs. Modeled Water Age (Sample C)**

**Figure 7** shows that chlorine residual and dissolved manganese were found to have a generally inverse relationship with water age during Sample C, similar to the trend observed in **Figure 5**.
